**Department for Environmental Protection Kentucky Division of Waste Management**

> November 3, 2016 Presented by Chris Jung

# **Bosch Tool**

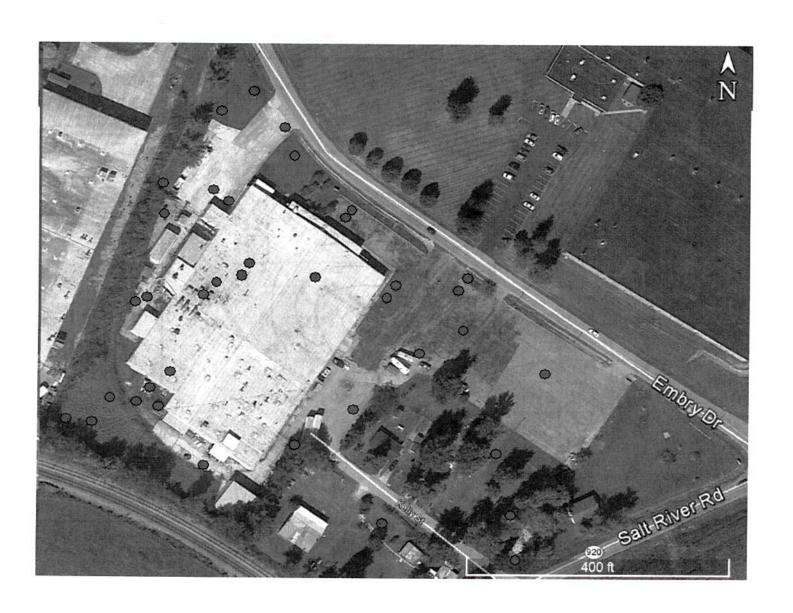
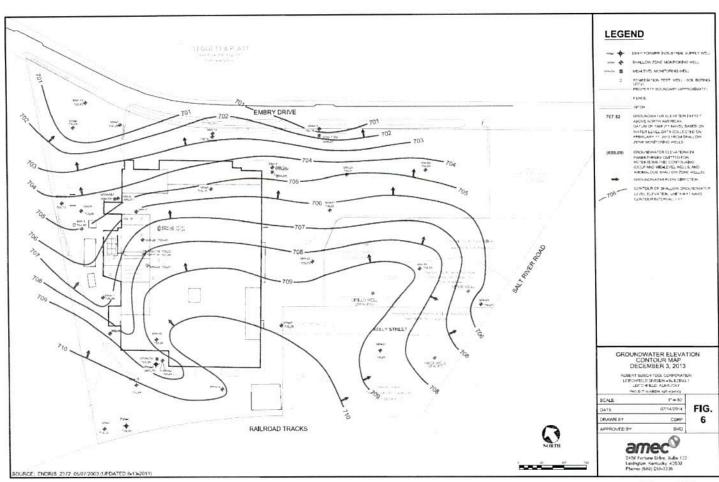
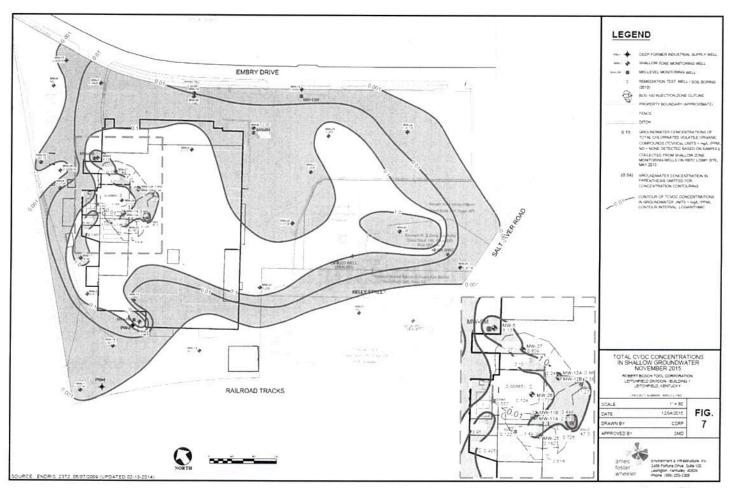
## **Groundwater Sampling Results**

The highest recorded monitoring well concentrations during the November 2015 sampling event were found in MW-5/MW-5M:

- TCE at 2.77 ppm (MCL .005 ppm)
- cis-1,2-DCE at 2.09 ppm (MCL .07 ppm)
- VC at 1.79 ppm (MCL .002 ppm)

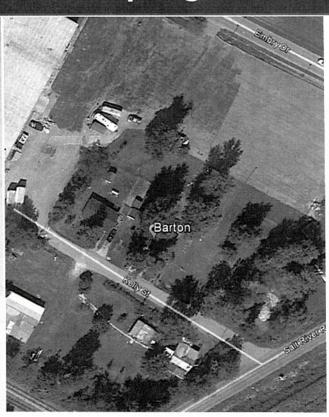
#### **Crawl Space Air Sampling**

- In 2012, crawl space sampling was conducted at the Barton property.
- Three locations were selected, and an 8-hour test was conducted.
- The highest recorded sample result was 2.0 µg/m³ TCE.
- Highest follow-up results was .83 μg/m³.

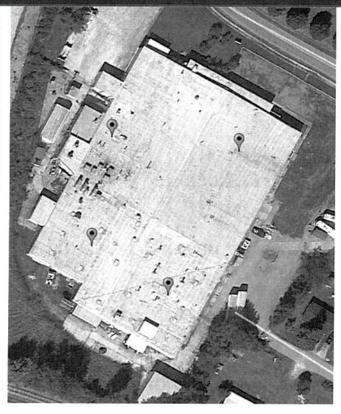
### **Indoor Air Facility Samples**

- Four locations were selected, and an 8-hour test was conducted.
- The highest recorded sample result was 13.4 μg/m³ TCE.
